# Robert Street Dam Removal - Restoring Migratory Fish Passage on the Raritan River, New Jersey

*John W. Jengo, PG, Principal Hydrogeologist, MWH/Stantec, Inc.  
Gene Meyer, PE, REM, Project Manager, Kinder Morgan, Inc.*

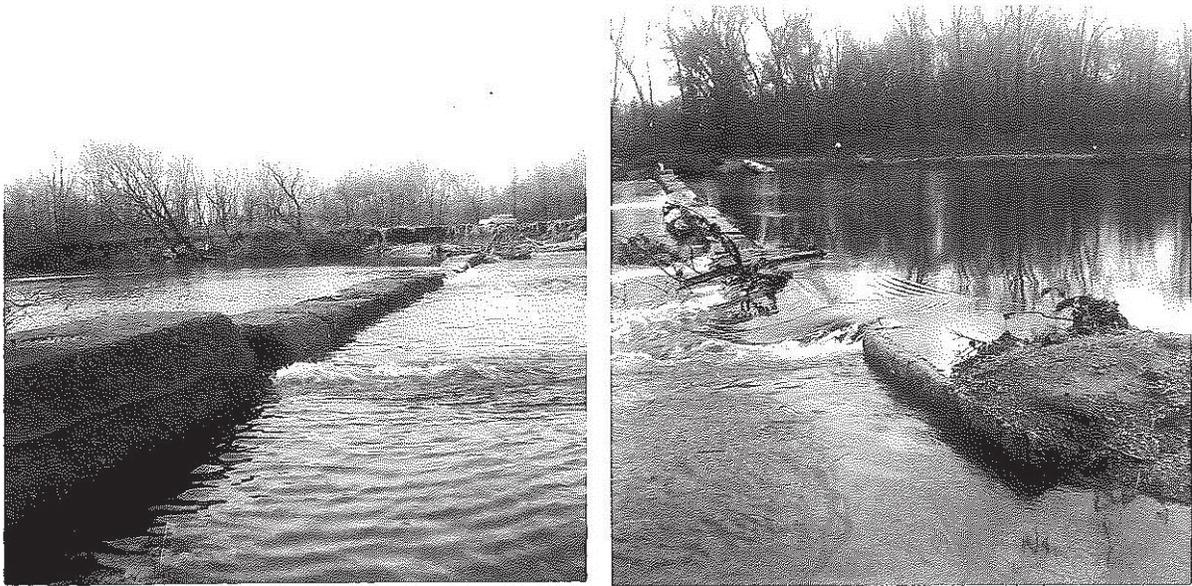
The original dam had a crest length of 250 feet and was approximately six feet in height with a concrete apron that extended approximately eight feet farther downriver. No records of this dam were on file at NJDEP Dam Safety Section (Dam Safety), but after months of diligent inquiries of adjacent property owners and engineering firms that were working in this area in the early 1960s, two photographs and a site plan of the original dam were acquired. The site plan was part of a December 1963 dam failure structural engineering assessment [6] and the inspection notations on this drawing include “dam overturned,” “dam settled and badly deteriorated,” “numerous structural cracks,” and “large structural crack.” Review of this information indicated that about 100 feet of the dam had settled and deteriorated because of water seepage and scouring of the underlying foundation material. This scour was most pronounced on the north end of the dam, which had caused a 15-foot section of the dam to overturn (Figure 3).

Figure 3. The original dam at the present-day Robert Street Dam location circa 1963 in a state of deterioration, subsidence, and failure; the left photo was taken from the south bank (river flow is from left to right) and the right photo was taken from the north bank where a section of the dam had overturned. Photos courtesy of Goodkind & O'Dea Consulting Engineers.

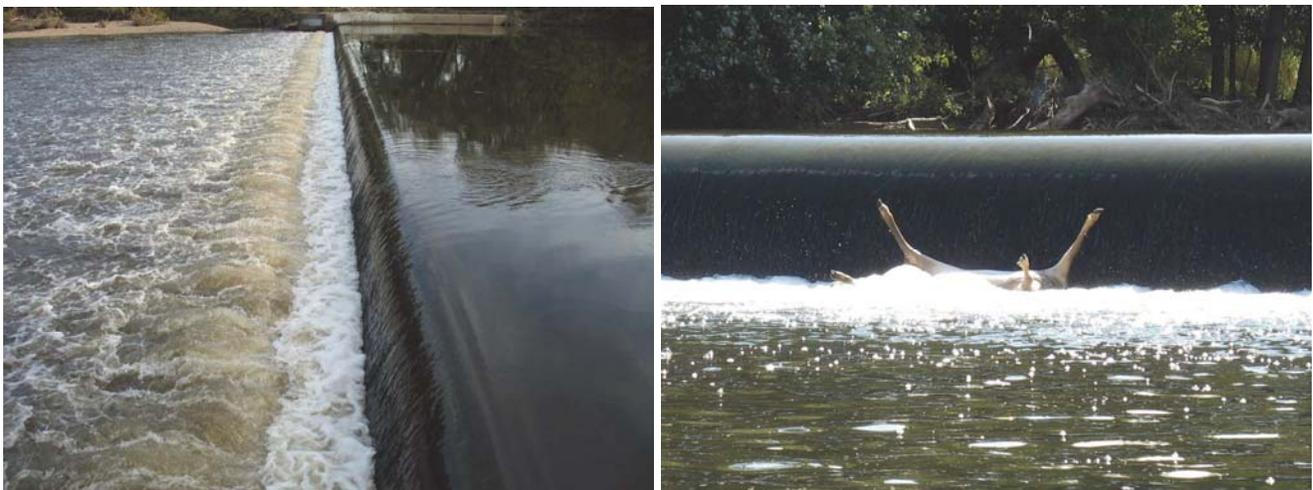
The design of the J-shaped base of the dam spillway created a powerful reverse roller and substantial hydraulic jump just a few feet downriver (Figure 6). At least one documented fatality occurred at the dam on June 17, 1989, and several other drowning victims found farther downriver may have been caused by entrapment in the Robert Street Dam reverse roller. Discussions with the Somerset County Duke Island Park rangers revealed that they have performed several rescues and resuscitations on individuals who were either fishing off the dam, or using it to cross the river when they slipped off and fell into the reverse roller. As such, it was not lost on the negotiators of the NRD settlement that there would be substantial public safety benefits to this dam removal in addition to eliminating a troublesome attractive nuisance at Duke Island Park.

Figure 6. Pre-dam removal image of the Robert Street Dam at Raritan RM 27.9 as viewed from the north bank of the river (left). There was at least one documented fatality of a boater who became trapped in the reverse roller at the base of the spillway. Deer swept off the dam while attempting to cross the river on the dam have also perished in the reverse roller (right). Copyright ©2016 John W. Jengo

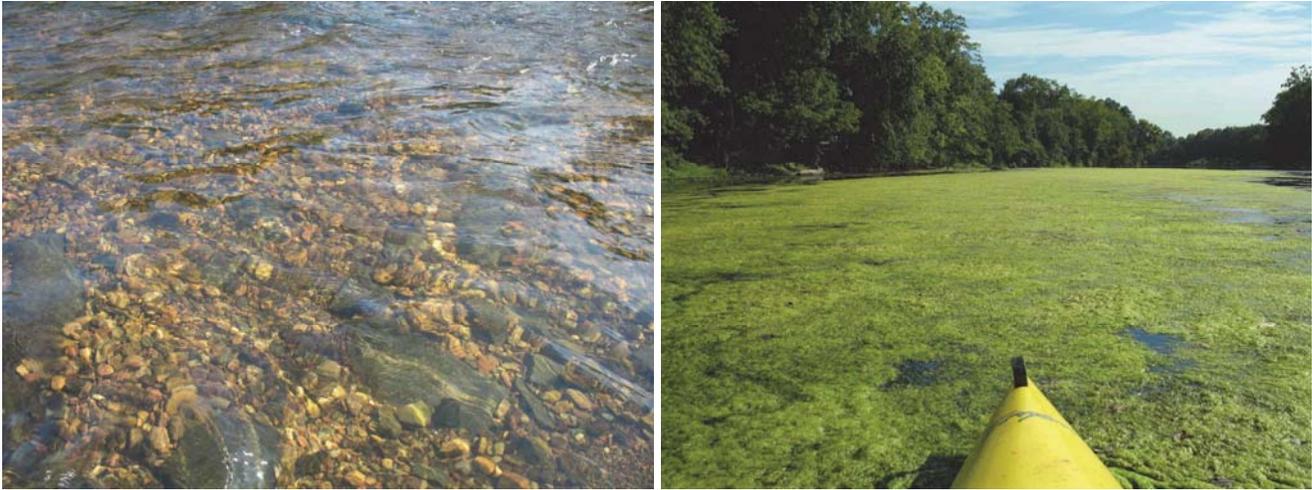
Figure 7. Clear water in the undammed reaches of the Raritan River reveal a clean sand, gravel, and cobble river bed substrate (left). The lake-like conditions upriver of the dams (right, above the Robert Street Dam) abetted the development of thick filamentous mat algae in the summer months, which triggered deleterious effects on water quality and aquatic life. Copyright ©2016 John W. Jengo

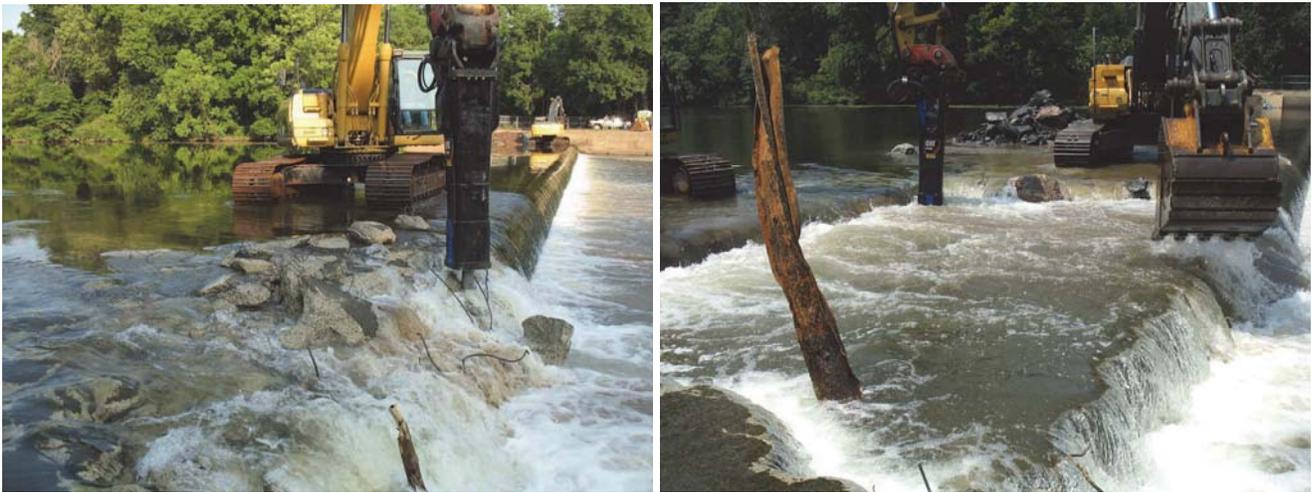
Figure 13. The initial breakup of the dam crest and concrete approach apron of the Robert Street Dam using the CAT Hammer model H140D S (left) with the objective of opening a 25-foot wide initial breach on the south end of the dam (right). Note the horizontal waler (sticking upright in the right photo) that had been pulled free from the downriver row of sheet piles (lower right). Copyright ©2016 John W. Jengo

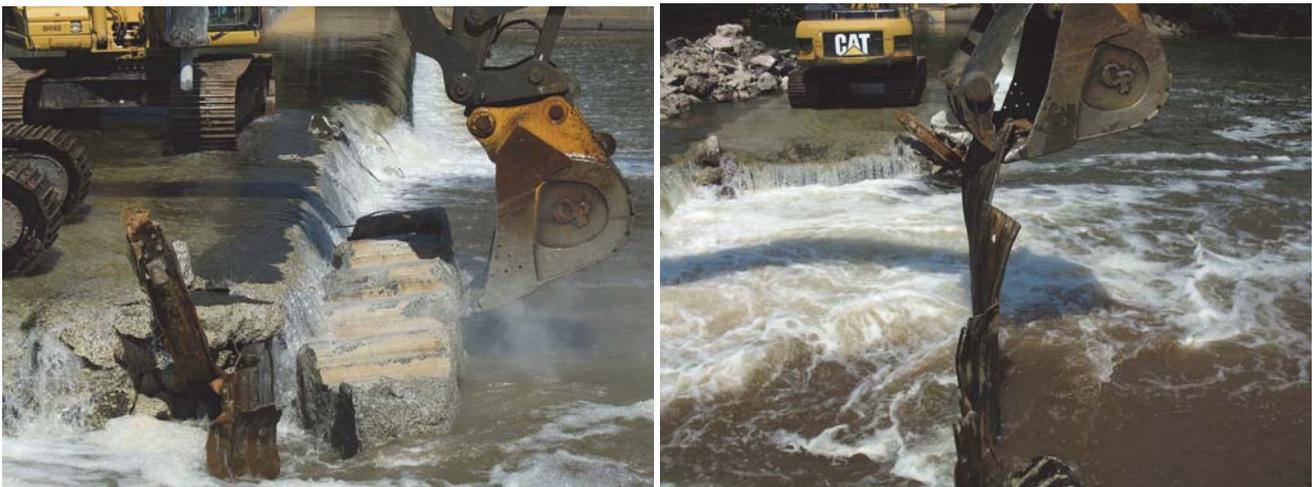
Although the dam removal commenced following the proposed Step 1 and Step 2 removal sequence, modifications were needed almost immediately because of the difficulty of extracting the sheet piles. Prior to the commencement of work, the depth and number of sheet piles fortifying the Robert Street Dam was unknown. As such, the demolition contractor planned to break apart the concrete approach apron and dam crest in order to expose the upper 1-2 feet of the sheet piles. The excavator bucket would then grapple onto the sheet piles and rock them back and forth to detach the sheets from their connections with adjoining sheets prior to lifting the sheets up and out of the river. It became apparent on the first few sheet piles that this approach was time consuming, tended to distort the upper sections of the sheets, and was generally ineffective in dislodging the sheet piles in an efficient manner (**Figure 14**).

Figure 14. The approach of hammering the dam crest directly above the downriver sheet pile resulted in large concrete sections being dislodged in a single piece, simplifying their removal from the river (left). The effort to rock sheet piles back and forth and lifting them with the excavator bucket was time consuming and was generally ineffective in dislodging the sheets in an efficient manner (right). Copyright ©2016 John W. Jengo

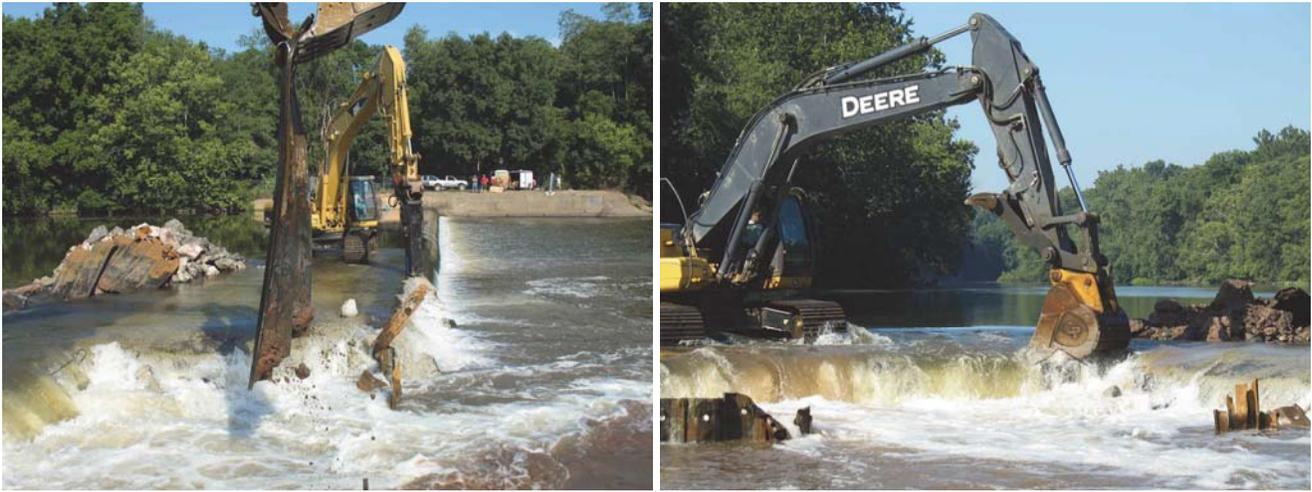
Figure 15. The level of effort required to remove sheet piles with the excavator bucket (left) indicated that a different extraction approach was needed. While awaiting the delivery of a hydraulic vibratory driver/extractor, unremoved sheets were bent forward in the initial breach to commence the dewatering of the upriver impoundment (right). Copyright ©2016 John W. Jengo

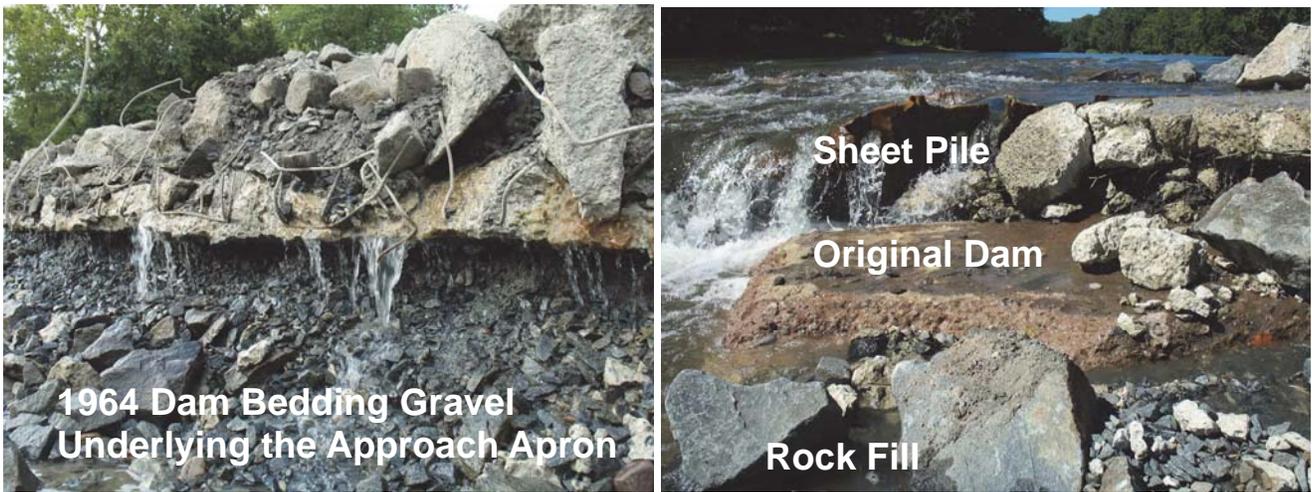
The work to uncover the top of the downriver row of sheet piles in preparation for vibratory extraction exposed the infrastructure of the Robert Street Dam and revealed how the dam was reconstructed in 1964 (**Figure 17**). The original dam was easily distinguishable by its reddish-pink coloration (a probable result of incorporating native Raritan River bedload as aggregate) and the sporadic distribution of both ⅝-inch round and ½-inch square rebar. R-4 to R-6 rock fill had been emplaced to fill the remaining space between the two rows of sheet piles and to bring the filled surface up to a consistent elevation (made necessary by the differential subsidence that had occurred to the original dam). Approximately 12-inches of bedding gravel (referred to as “stone fill topping” on the original design drawings) was laid down to create a level bed to support the concrete pour of the 8-inch thick concrete approach apron, which incorporated a dense web of ¼-inch rounded steel wire mesh.

Figure 17. View of the infrastructure of the Robert Street Dam, the ¼-inch rounded steel wire mesh-supported concrete approach apron underlain by bedding gravel (left), which covered both the pinkish-colored original dam and R4 to R6 rock fill between the parallel rows of sheet piles (right).  
Copyright ©2016 John W. Jengo

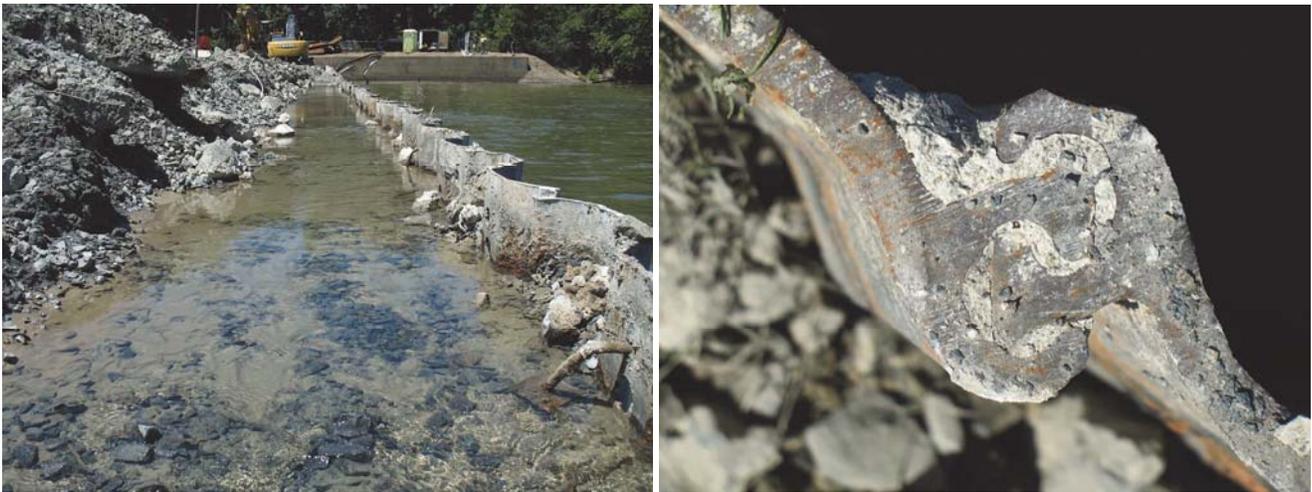
Evaluation of the sheet piles indicated that they were contiguous U-sheet piles with Union straight web section interlocks positioned at both flange ends (**Figure 18**). Although most of the upper contacts of the sheet piles were filled with concrete, the sheets were not grouted together at depth. The sheets, marked “Bethlehem” (undoubtedly sourced from Bethlehem Steel) had a section width of approximately 20-inches, with a 6-inch section depth, and varied slightly in thickness between ⅜-inch to ½-inch. The weight of a typical 13-foot long sheet (after cemented rock fragments were cleaned off) was 360 pounds.

Figure 18. The downriver row of sheet piles awaiting extraction after the concrete dam crest and concrete approach apron had been removed (left). The sheet piles were identified as U-sheet piles with Union straight web section interlocks (right). Copyright ©2016 John W. Jengo

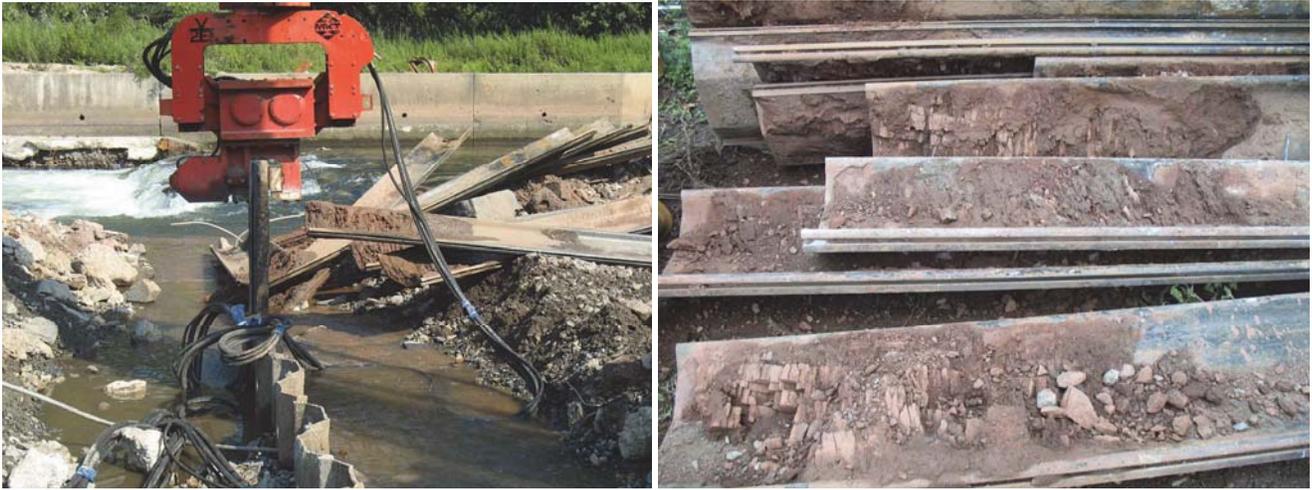
Two types of vibratory extractors were ultimately used to extract the sheet piles. After five days of use (with the first two days dedicated to removing the downriver and upriver sheet piles in and around the initial breach), the first vibratory extractor (MKT Manufacturing, Inc.’s Model V-2ES) was found to be working beyond its capacity to vibrate and lift the sheets, and a failure occurred in the power unit when attempting to extract a particularly recalcitrant sheet. Although the sheets were not grouted into bedrock, naturally occurring cementation with the siltstones and mudstones of the Triassic-age Passaic Formation had locked the sheet piles so tightly in place that ultimately the bedrock had to be shattered to release the sheet pile from the subsurface (**Figure 19**).

Figure 19. Use of MKT Manufacturing, Inc.'s V-2ES vibratory extractor in the initial phases of the sheet pile extraction (left). Nearly every extracted sheet pile had fragments of bedrock attached (right), which indicated that naturally occurring cementation with the siltstones and mudstones of the Triassic-age Passaic Formation had served to firmly lock the sheet piles in place. Copyright ©2016 John W. Jengo

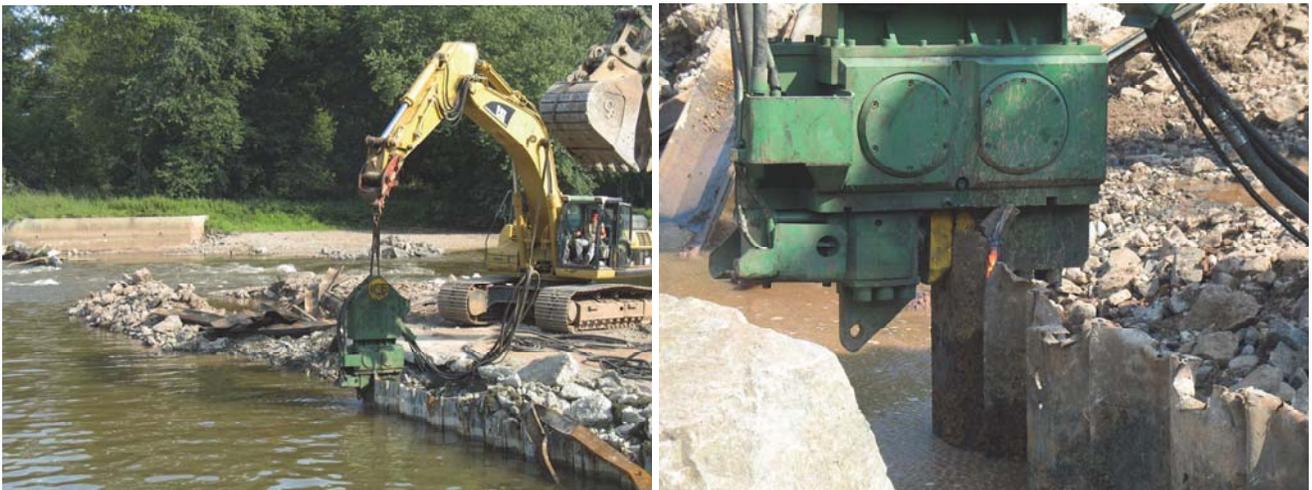
Figure 22. The ICE Model 11-23 vibratory extractor was ideally suited to extract the remaining Robert Street Dam sheet piles (left) and overcome the resistance of the interlocks, which often superheated during the extraction procedure (right). Copyright ©2016 John W. Jengo

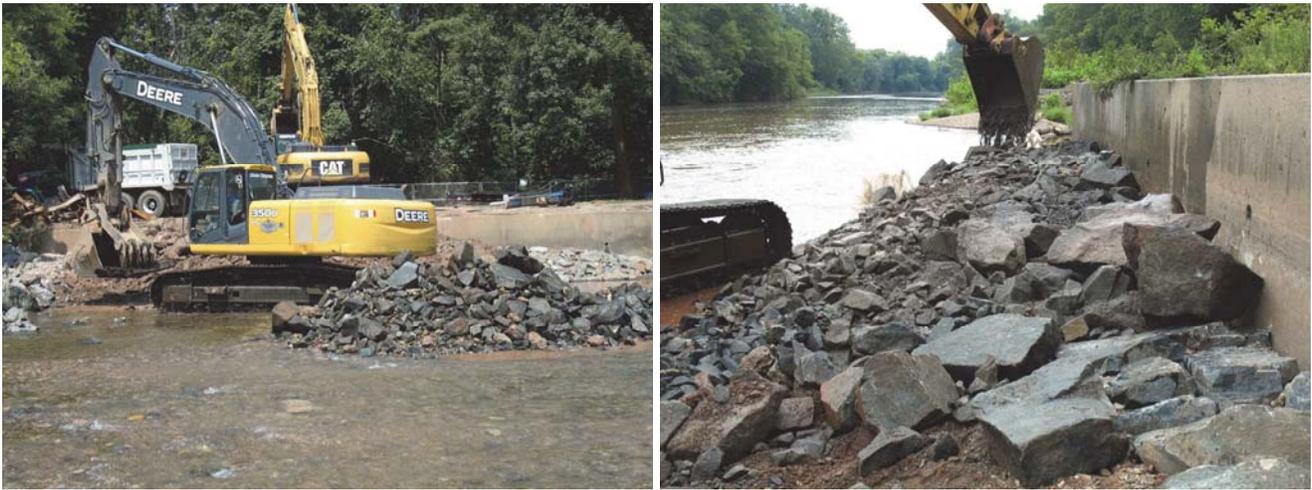
The size of the rock fill between the sheet piles that encased the original dam, which generally ranged from R-4 through R-6, was ideally suited for reuse as riprap to stabilize the dam abutments, which was one of the conditions that the land owners on both sides of the river had stipulated. The reuse of the rock fill provided both structural support for the abutments and protection from the scouring action of the river along the newly-exposed base of the walls (**Figure 25**).

Figure 25. After excavation, the salvaged R-4 through R-6 sized rock fill was segregated (left) and stockpiled for use in stabilizing the former Robert Street Dam abutments (right). Copyright ©2016 John W. Jengo

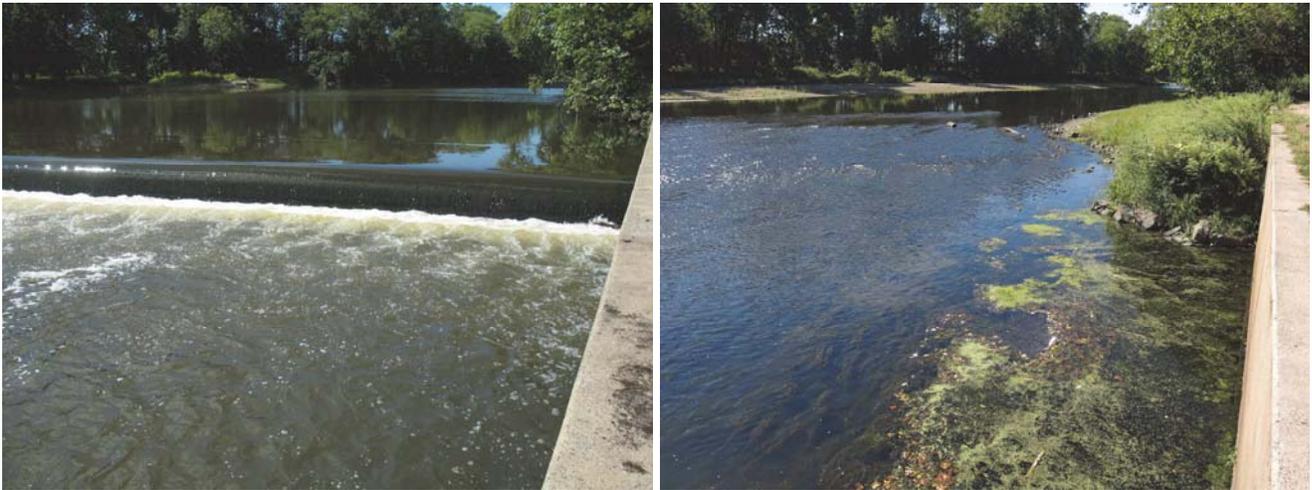
Figure 30. A before (left) and after (right) view of the Robert Street Dam facing west (looking upriver) from the north bank of the river. In the photo on the right, note the growth of vegetation that has completely covered the abutment-supporting riprap as compared to the same view in the right-hand photo in Figure 29. Copyright ©2016 John W. Jengo

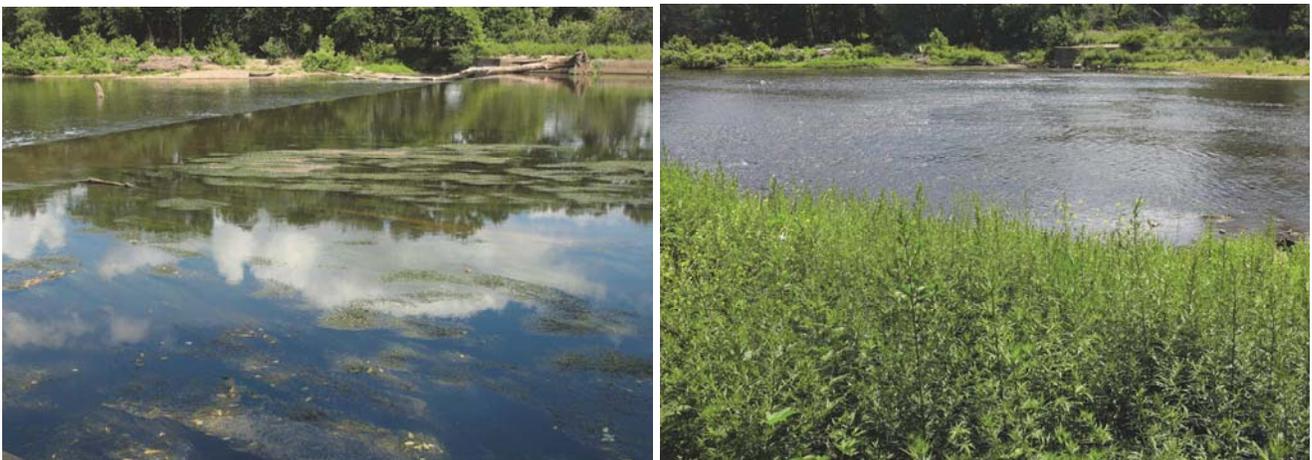
Post-dam removal observations have verified the elimination of the filamentous mat algae and stagnant water conditions behind the former Robert Street Dam and have shown that the natural river process of transporting sediment, woody debris, and nutrients has been fully restored (**Figure 31**).

Figure 31. A before (left) and after (right) view of the Robert Street Dam facing southeast across the former dam alignment and impoundment from the north bank of the river. Copyright ©2016 John W. Jengo
