# Robert Street Dam Removal - Restoring Migratory Fish Passage on the Raritan River, New Jersey

*John W. Jengo, PG, Principal Hydrogeologist, MWH/Stantec, Inc.  
Gene Meyer, PE, REM, Project Manager, Kinder Morgan, Inc.*

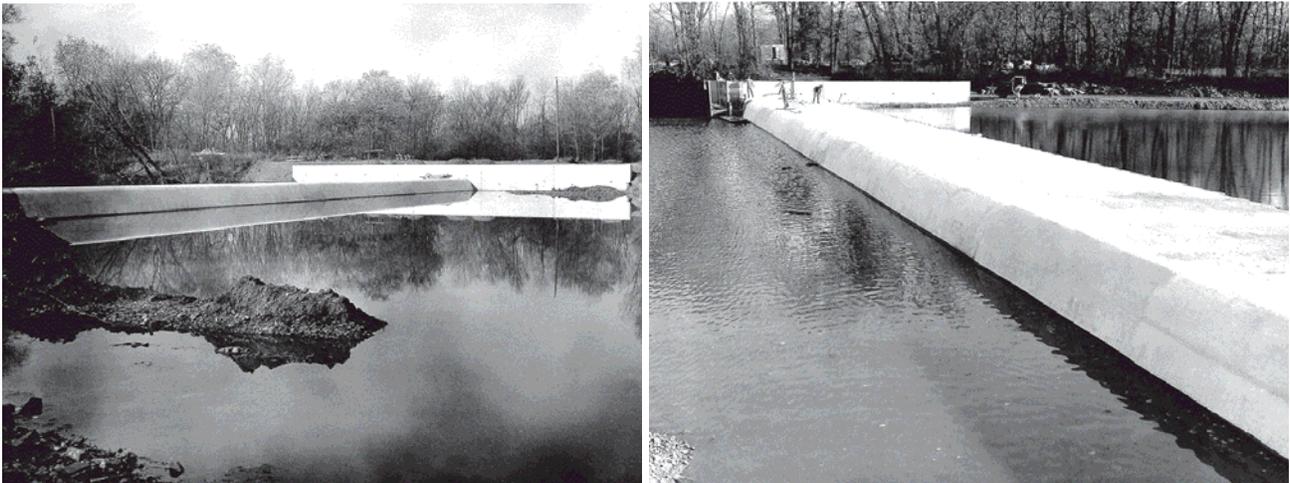
The owner of the dam at that time, the Park Commission of Somerset County, funded a substantial 1964 reconstruction of the dam for recreational boating, presumably to create an impoundment adjacent to the newly-opened Duke Island Park upriver of this location. Upon completion, the reconstructed dam had a crest length of 255 feet and had a width of 23 feet (**Figure 4**).

Figure 4. The reconstruction of the Robert Street Dam location in 1964; the left photo was taken from the south bank (river flow is from left to right) and the right photo was taken from the north bank. It is evident from these photos that the river was diverted around the construction site; present-day observations indicated that this was most likely accomplished via a bypass channel along the south bank (background of right photo). Photos courtesy of NJDEP Dam Safety.

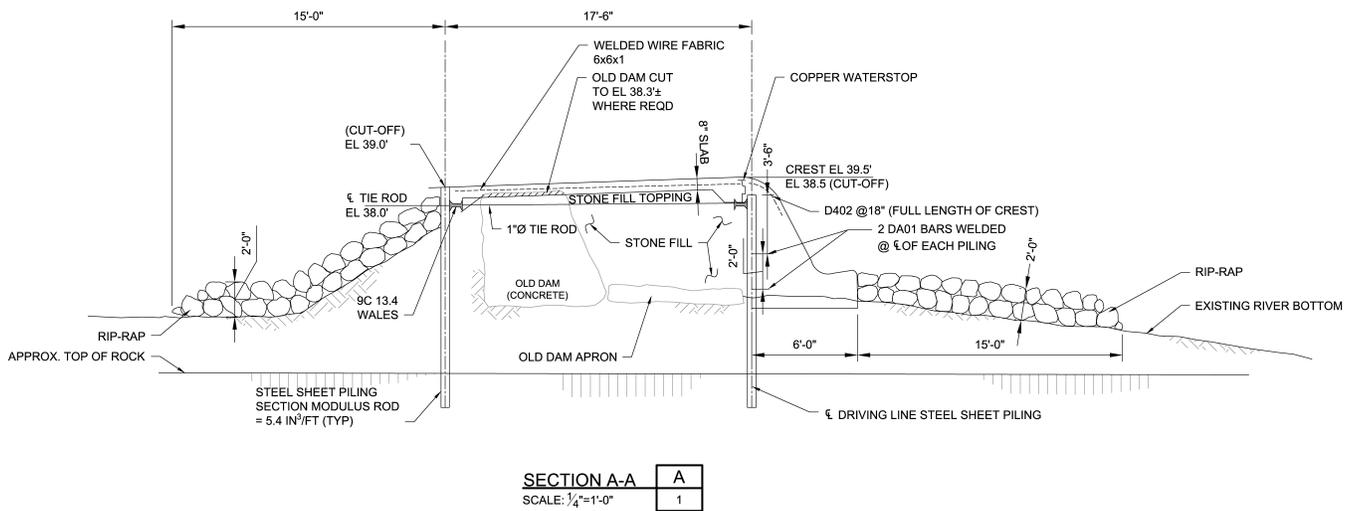
Because the Dead River Dam and the Headgates Dam (located two miles upriver) had both failed in the space of just four years from undermining, cutoff walls became the key feature of the reconstruction effort. During the 1964 reconstruction, the original dam structure was encased between two parallel rows of water-supported steel sheet piles, spaced 17.5 feet apart, which were driven into bedrock to an undocumented depth (**Figure 5**). The horizontal water beams were composed of two 9-inch by 2.5-inch steel channels bolted together back-to-back to create ad hoc I-beams, and these walers were then bolted to the sheet piles using  $\frac{3}{4}$ -inch bolts. A total of 16 one-inch diameter solid steel tie-rods, spaced 16.35 feet apart, were installed to secure the upriver and downriver rows of sheet piles together (and the original dam was notched in locations where the structure interfered with the installation of these tie-rods).

Figure 5. The author’s redrawn Robert Street Dam as-built profile showing the encasement of the original “Old Dam” and “Old Dam Apron” between parallel rows of steel sheet piles; river flow is from left to right.

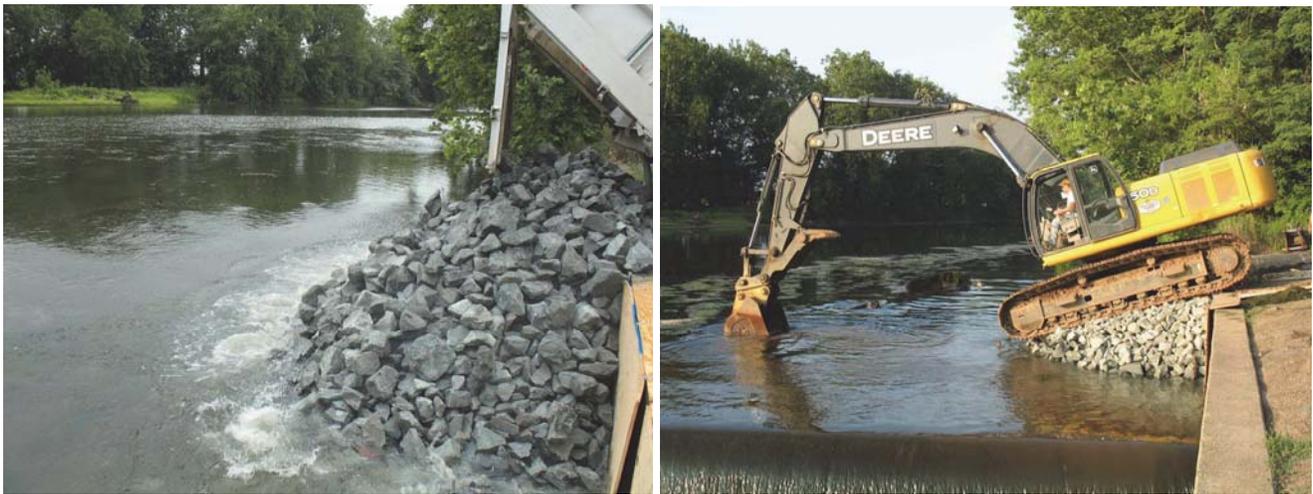
Figure 12. To avoid damage to the natural river embankment, loads of stone were dropped into the river to construct a temporary ramp extending outward from the north shore dam abutment (left); this ramp was used throughout the project to bring the excavators in and out of the river (right).  
Copyright ©2016 John W. Jengo

On the appointed day of the initial dam breaching, the river discharge was at 204 cfs, nearly 100 cfs lower than the maximum permitted flow specified in the Dam Safety Permit. Using a temporary rock ramp that was emplaced at the northern dam abutment several days earlier, the excavators were mobilized into the river and over to the south end of the dam using the concrete approach apron as an ad-hoc causeway (**Figure 12**).

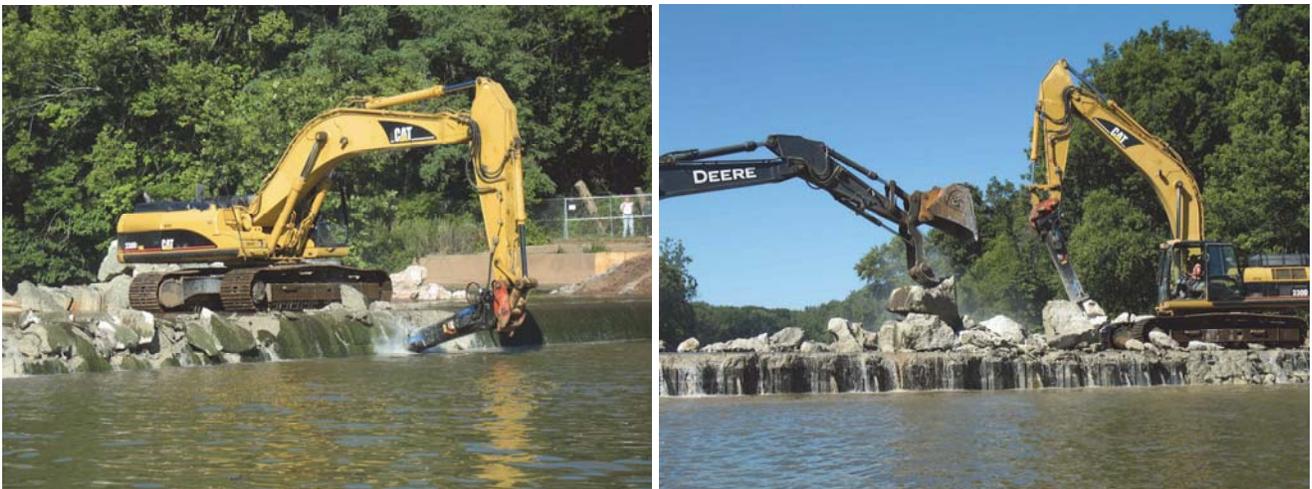
While awaiting the delivery of the vibratory extractor, the contractor continued to break apart the concrete approach apron and dam crest to expose the top of the downriver row of sheet piles working from the south bank to the north bank (**Figure 16**). This work revealed that ½-inch thick rounded rebar was used to provide cantilever support to the overhanging dam crest.

Figure 16. Work proceeding on the breakup and removal of the dam crest across the dam (left) to expose the downriver row of sheet piles (right). Copyright ©2016 John W. Jengo

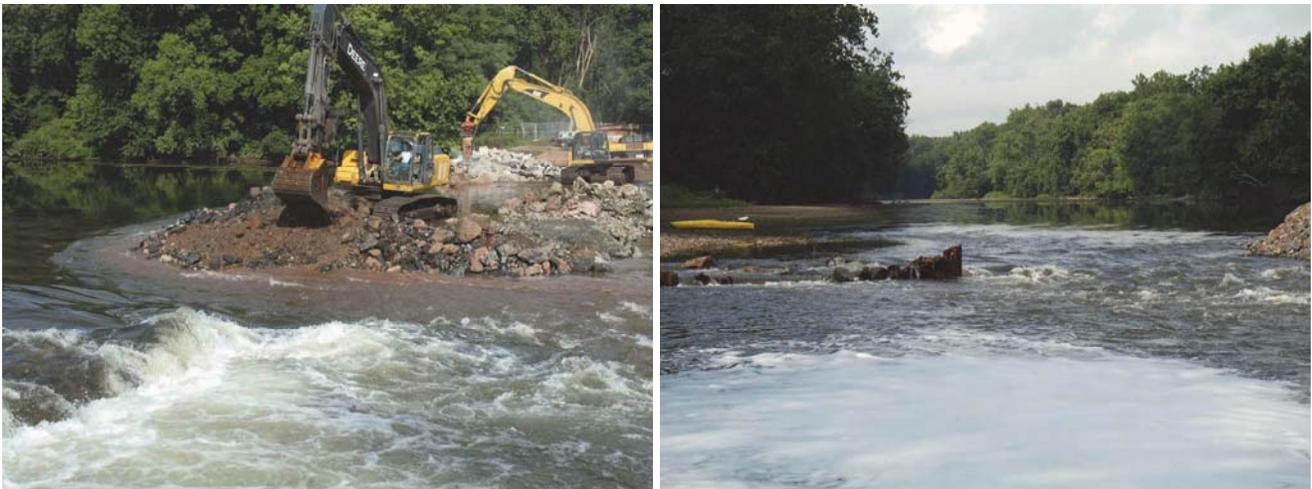
Figure 20. View of the initial dam breach looking toward the north bank (left) and from downriver to upriver from the south bank (right). Copyright ©2016 John W. Jengo

A decision was made to replace the MKT unit, which would be delivered to the site in 24 hours. In the meantime, work continued on excavating the original dam and rock fill between the sections of the extracted upriver and downriver sheet piles down to the pre-dam river bed elevation and deepening/widening the dam breach to complete the dewatering of the upriver impoundment (**Figure 20**).

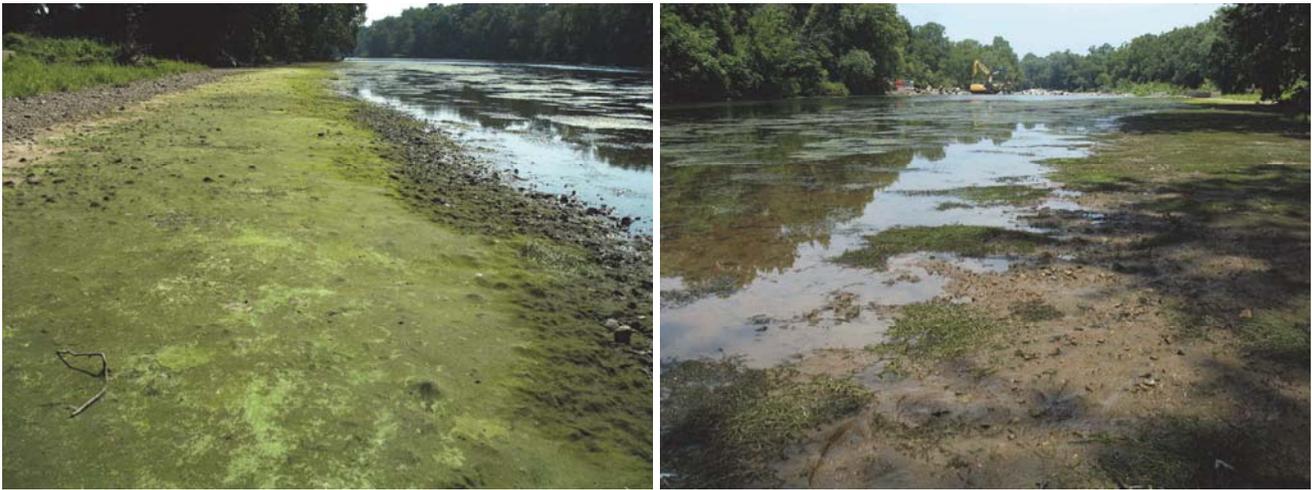
As expected from the pre-dam removal river bed survey (**Figure 8**), the shallow river bed on the south side of the river was broadly exposed after the impoundment water level was permanently lowered. A broad swath of filamentous mat algae and other aquatic plants were stranded and carpeted the former river bed margins (**Figure 21**). It was not necessary to remove this material or seed the exposed river bed because prior dam removal experience on the Raritan River had indicated that this algae and plant material would degrade quickly and the exposed river bed would begin to vegetate naturally within a few weeks.

Figure 21. The exposed Raritan River bed following the final dewatering of the Robert Street Dam impoundment, looking upriver at stranded filamentous mat algae (left) and looking downriver at other stranded aquatic plants toward the dam site (right). Copyright ©2016 John W. Jengo

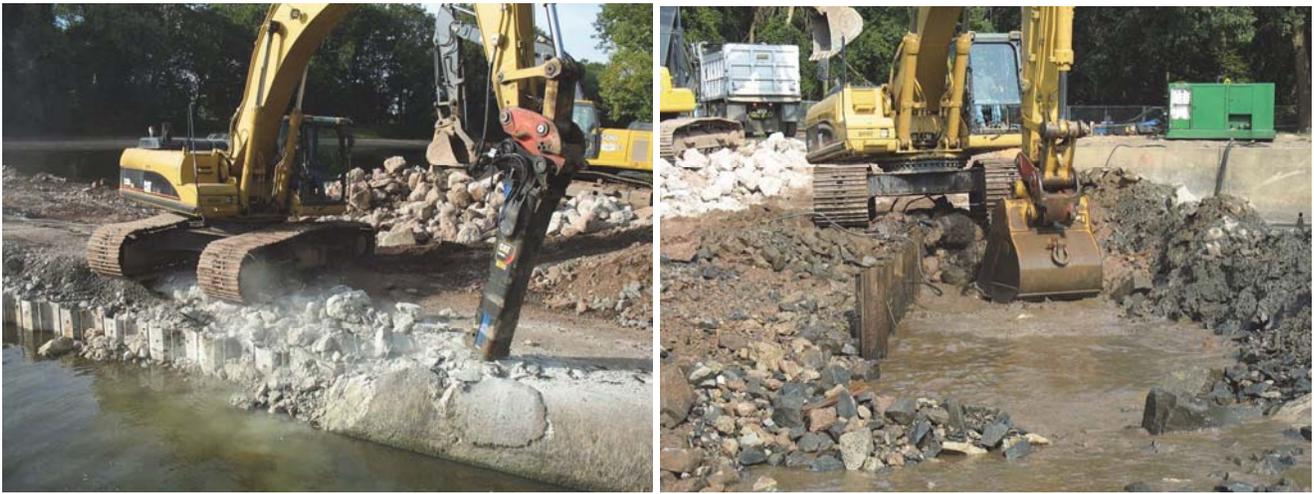
Figure 23. Staging the excavator on the rock backfill of the original dam to remove the remaining dam crest to expose the downriver row of sheet piles nearest to the north abutment (left); concrete and excavated rock fill material was then emplaced as a temporary causeway/working platform upstream of the upriver row of sheet piles (left side of right photo). Copyright ©2016 John W. Jengo

Use of the vibratory extractors necessitated making an adjustment to the planned dam removal sequencing outlined above. Firstly, the rock fill and the original dam between the sheet piles was kept intact after the removal of the concrete approach apron for use as a stable platform for (i) the excavators to remove the remaining dam crest and expose the top of the sheet piles, and (ii) the vibratory extractor power unit and excavator to remove the downriver row of sheet piles. Then, during the subsequent excavation of the rock fill and the original dam, some of that material was emplaced *upstream* of the upriver row of sheet piles to create a causeway/working platform for the excavators to facilitate the subsequent removal of the upriver sheet piles, which also required moving the access/egress ramp on the north embankment off the dam (**Figure 23**). The reason was self-evident – a stable platform was needed to stage the nearly 5-ton power unit of the vibratory extractor and have the excavator with the vibratory extractor positioned astride the sheets that were being pulled (in addition, this temporary platform was also utilized to stage the compressor for the CAT hammer).

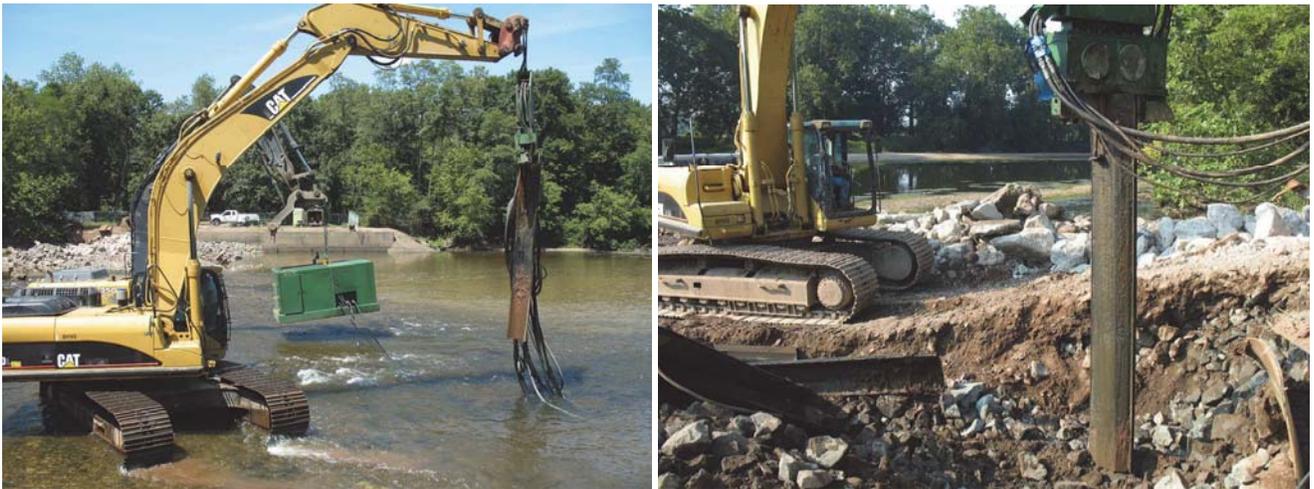
Figure 24. The final downriver sheet pile extraction (left) and final upriver sheet pile extraction (right). In the right hand photo, note that the access/egress ramp was moved upriver off the dam from its original position shown in Figure 12. Copyright ©2016 John W. Jengo

With this revised sequencing into place, the last remaining sheet piles were extracted (**Figure 24**), although one or two of the sheet piles were left in place nearest the base of the abutment walls for support. This final extraction effort did require returning to several sheet piles to cut away upper sections that were distorted or shredded by the initial excavator extraction attempts. This was necessary to fashion a clean, straight surface at the top of the sheet piles to grapple with the extractor clamps, which had a fairly narrow throat width. The dam removal then concluded when the remaining original dam remnants and rock fill was excavated and removed from the river, progressing from the far south bank of the river to the near north bank.

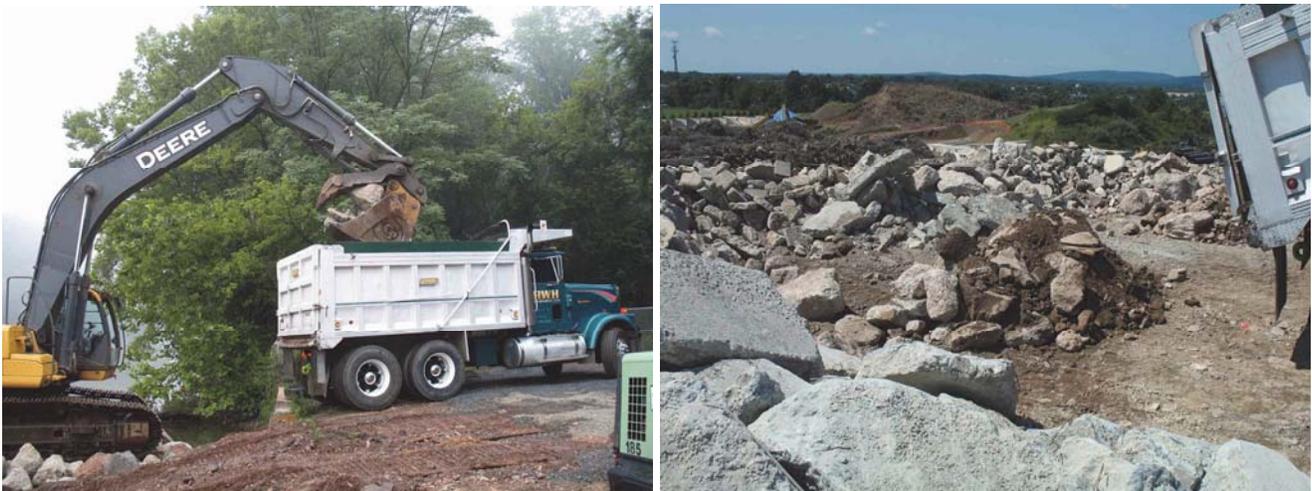
Figure 26. Loading of dam concrete debris into one of the haul trucks for transport off-site (left). The concrete debris was brought to a New Jersey Approved Class B concrete recycling facility for crushing and subsequent reuse (right). Copyright ©2016 John W. Jengo

Throughout the project, concrete debris was conveyed to the north bank by using both excavators in a “bucket brigade” fashion. After the concrete debris had been stockpiled at the north bank and “downsized” by the excavator equipped with the CAT hammer (during times when that equipment was not needed for in-river dam demolition), the debris was directly loaded into haul trucks. A total of 96 round trips were needed to convey 702 tons of concrete debris off-site, while staying below the Robert Street Bridge load capacity (the average net weight of the concrete per load was 7.3 tons). When one of the excavators could remain dedicated to loading the haul trucks, two trucks were employed on certain days that allowed a maximum of 14 trips off-site per day. The material was hauled to a New Jersey Approved Class B Recycling Facility (Vollers’ recycling facility in Branchburg, New Jersey), a 12-mile roundtrip from the dam site, to be recycled (**Figure 26**). The recycled concrete would ultimately be crushed and then reused in roadways, driveways, and building pads rather than take up valuable space in local landfills.

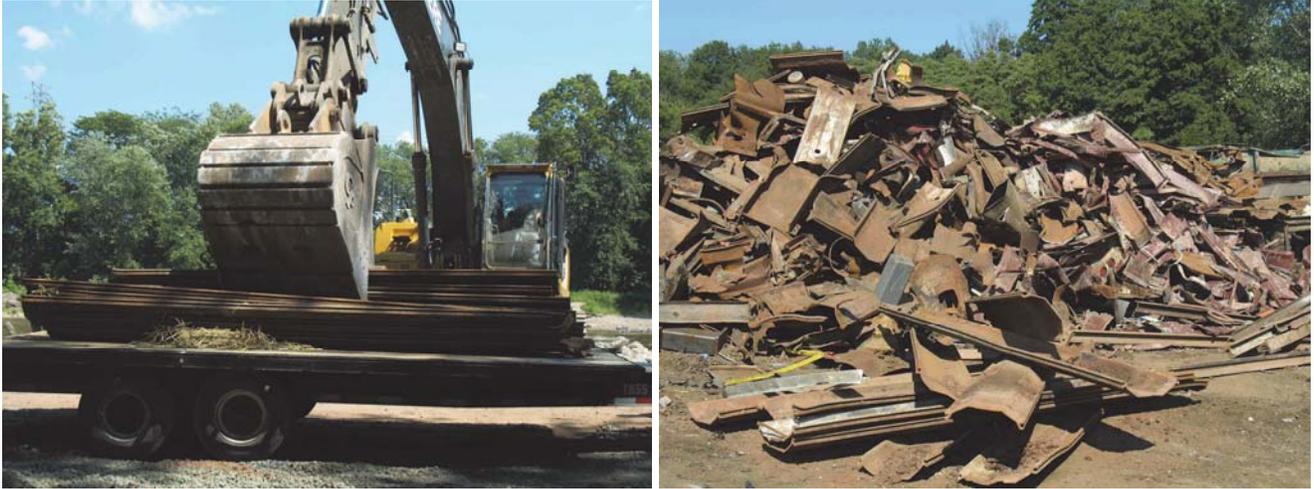
Figure 27. Loading some of the 300 individual steel sheet piles onto a trailer for transport off-site (left). The steel sheet piles were brought to a local facility (right, foreground) for ferrous metal recycling. Copyright ©2016 John W. Jengo

Over 70 tons of steel, primarily the extracted sheet piles and waler beams, were conveyed off to Klein Recycling in Hillsborough Township, New Jersey, an 11.5-mile round trip from the dam (but in the opposite direction of the concrete recycling facility), for ferrous metal recycling (**Figure 27**).

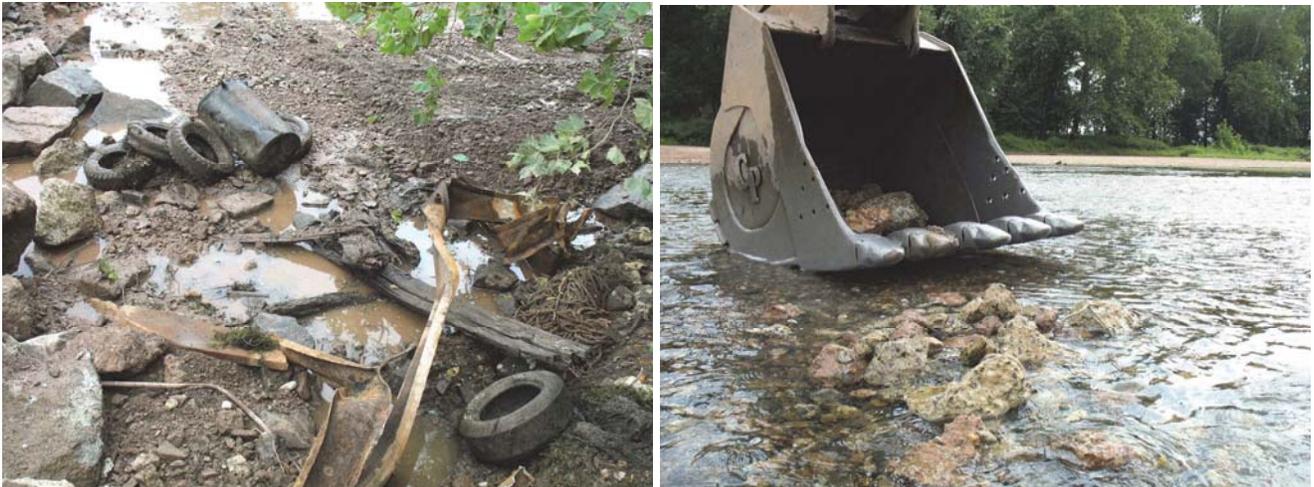
Figure 28. Retrieval of unrelated debris that emerged from the dewatered dam impoundment (left) and meticulous collection of small pieces of concrete along the demolished dam alignment (right) was performed during the restoration phase of the Robert Street Dam removal. Copyright ©2016 John W. Jengo

The Robert Street Dam removal project was the largest dam removal in the Raritan River watershed to date and was a highly visible effort that received significant local and regional press coverage, many interested observers, and intense regulatory scrutiny. Such public exposure helped justify a particularly diligent restoration effort and the addition of unanticipated tasks, namely the retrieval of all manner of debris that was exposed when the dam impoundment was drained. Empty tanks, rope, hose reels, bicycles, and numerous car and truck tires and ancillary automobile parts and other debris were retrieved and disposed of properly off-site, courtesy of Somerset County. In addition, as the river clarity improved and flows decreased in mid-August in the final days of the project, the river bed was canvassed each day to manually retrieve small pieces of concrete and steel wire mesh (**Figure 28**). By the end of the project, all anthropogenic material greater than a few inches in size had been removed from the river bed.

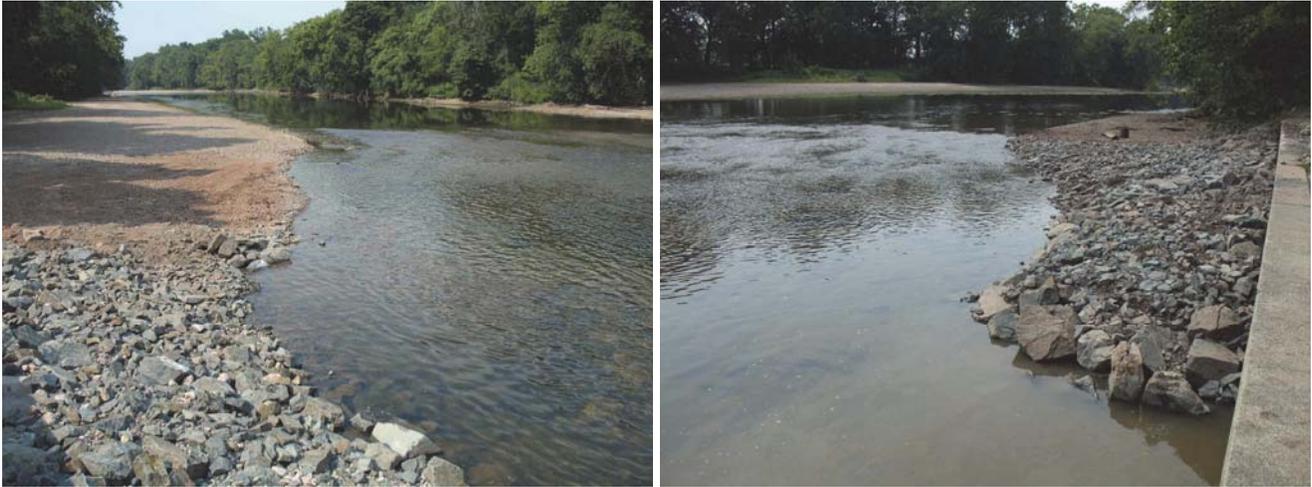
Figure 29. Mounded gravelly sand bedload from behind the dam was moved to the shorelines, which were contoured and graded to blend in with the excavated dam rock fill on the south (left) and north (right) river banks that had been emplaced to support the former dam abutments.  
Copyright ©2016 John W. Jengo

Lastly, to create a smooth shoreline transition, emergent gravelly sand beaches on both sides of the river were supplemented with the bedload that was excavated from behind the dam and then contoured to connect and blend with the salvaged R-4 to R-6 rock fill that had been emplaced to support the former dam abutments (**Figure 29**).

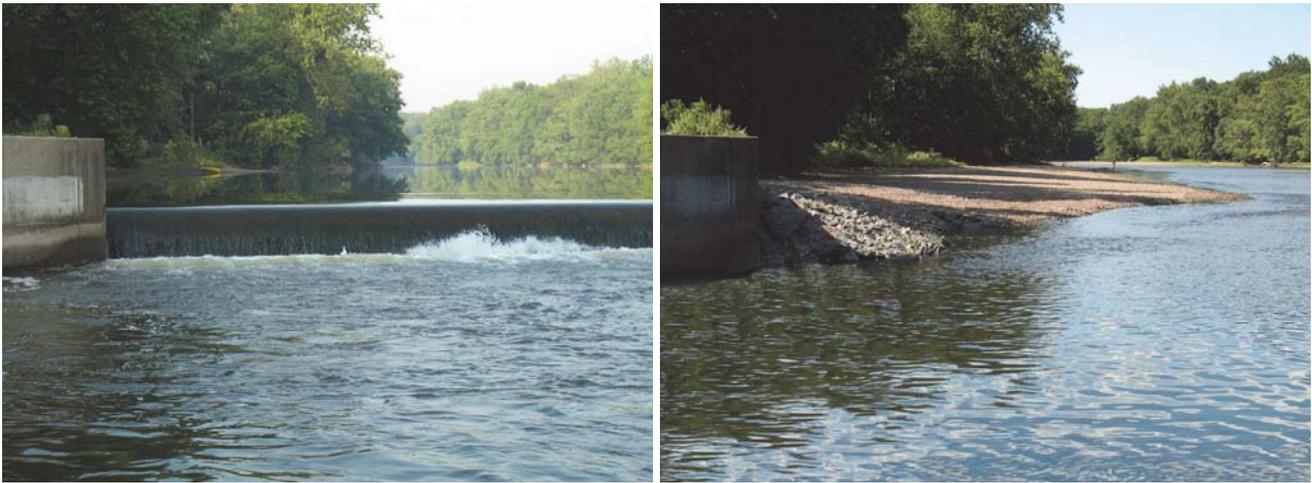
Figure 32. A before (left) and after (right) view of the Robert Street Dam facing west (looking upriver) from the south bank of the river.  
Copyright ©2016 John W. Jengo

The re-establishment of flowing water and emergence of shallow sand bars and beaches along the river's edge are now providing the diversity of habitats necessary for fish species and other species such as the American eel, bald eagle, great blue heron, and great egret to survive and thrive. The elimination of a significant public safety hazard has also increased recreational use of the river, including kayaking, canoeing, and fishing (**Figure 32**).
